**DM McMahon Pty Ltd**

Re: Soil monitoring in the tree plantations, crops, and pastures irrigated with treated effluent from the Visy Albury Paper Mill

The objective of this report is to satisfy the conditions of the NSW EPA Environmental Protection Licence No. 1272 around the effluent application to land.

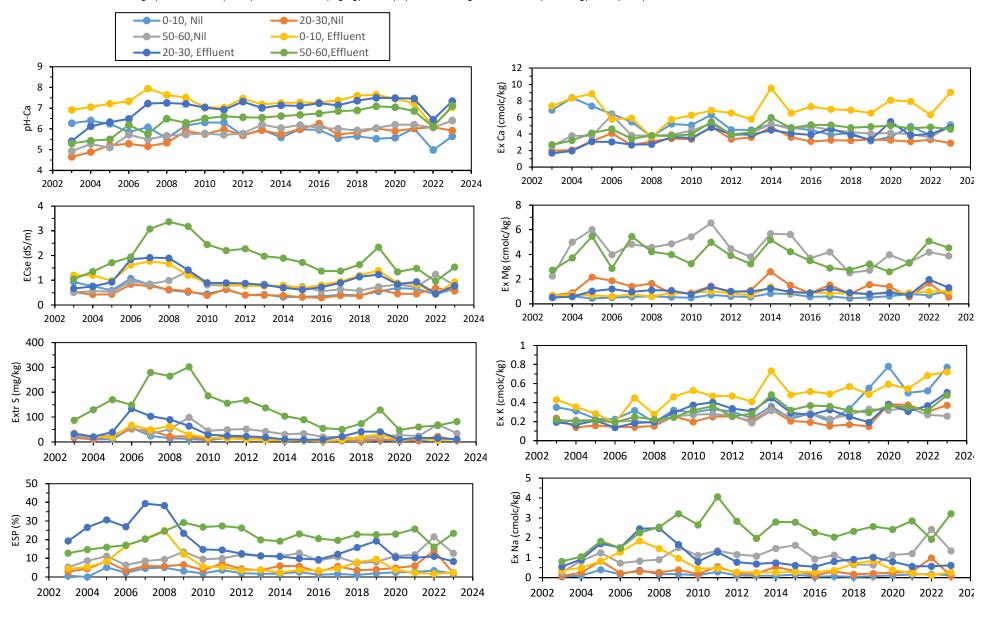
Attachment D: Average pH-Ca, ECse (dS/m), extractable S (mg/kg), ESP (%) and exchangeable cations (cmolc/kg) in crops & pastures soils since 2003.

- Average pH (1:5 CaCl<sub>2</sub>) ranged from 5.64 to 6.40 in the un-irrigated plots, and between 7.04 and 7.33 in plots irrigated with effluent. Average pH (1:5 CaCl<sub>2</sub>) increased from the 2022 results to levels similar to 2021.

- Average salinity (ECse) ranged from 0.56 to 0.80 dS/m in the un-irrigated plots, remaining steady to slightly decreasing from 2022 levels. In the irrigated plots, average ECse ranged from 0.78 to 1.53 dS/m remaining relatively stable or slightly increasing from 2022.

- Average exchangeable cations (Ca, Mg, K, Na) generally decreased from 2022 levels with some minor variation in calcium and magnesium in the subsoil (80-90cm).

- Average exchangeable sodium percentage (ESP) was recorded as 1.79% (0-10cm), 2.08% (20-30cm), and 12.64% (50-60cm) in the un-irrigated plots decreasing from 2022 levels. The ESP was recorded at 2.35% (0-10cm), 8.32% (20-30cm), and 23.36% (50-60cm) in the irrigated areas increasing from 2022 levels at depth.

- Average extractable sulphur in the un-irrigated plots was similar to or lower than 2022 levels, ranging from 5.40 to 34.40 mg/kg. Levels were similar to or slightly higher than 2022 in the effluent irrigated plots, ranging from 10.00 to 82.08 mg/kg.

Within the pasture plots (both un-irrigated and irrigated) some minor seasonal variations are noted, these likely attributable to changes in irrigation water quality and the amount of irrigation occurring in 2023 owing to the above average rainfall in 2022 and from January to June 2023.

It is recommended that the practice of an annual review of the cropping systems and irrigation management is conducted to ensure the maximum sustainable assimilation of nutrients and hydraulic load is occurring.

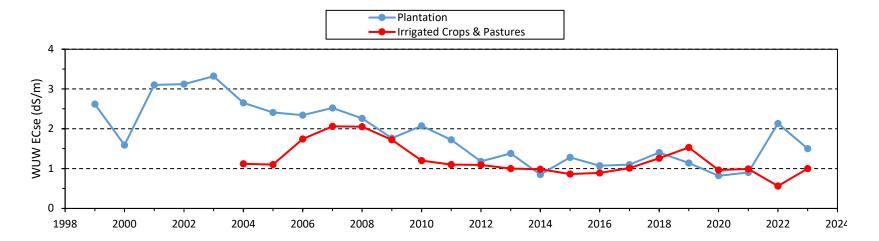
Attachment F: Average salinity (WUW Ecse) in the root zones of plantation soils (0-90cm) and crops & pasture soils (0-60cm) irrigated with effluent.

- Average salinity in the root zone of the plantation areas was 1.5 ± 1.3 dS/m. Plantation soil salinity has decreased from 2022.
- Average salinity in the root zone of the effluent irrigated crops and pasture areas was 1.0 ± 0.4 dS/m. The average soil salinity has increased slightly from 2022.
- Average soil salinity in the root zone of the un-irrigated crops and pasture areas was  $0.7 \pm 0.2$  dS/m. Soil salinity has remained steady from 2022.
- The coefficient of variation of average soil salinity ranged from 36% (irrigated crops & pasture) to 89% (plantation), which is variable compared to previous monitoring results.

The inherent soil characteristics of the poorly drained yellow sodosols on the footslopes provides some challenges to irrigation management as can be seen by higher sodicity and salinity in the subsoils in the tree plantation, crop, and pasture areas, however average levels of soil salinity remain well below the Load Based Licencing threshold of 4.0 dS/m.
